NEW SITE IDENTIFICATION (NSI)

Part A – NEW SITE IDENTIFICATION INFORMATION (To be completed by the Task Lead for New Site)	
1. Site Title: Soil Beneath TAN-607 Decontamination Shop Sump	Site Code: TSF-54 NSI Evaluation Initiation Date: March 24, 2005

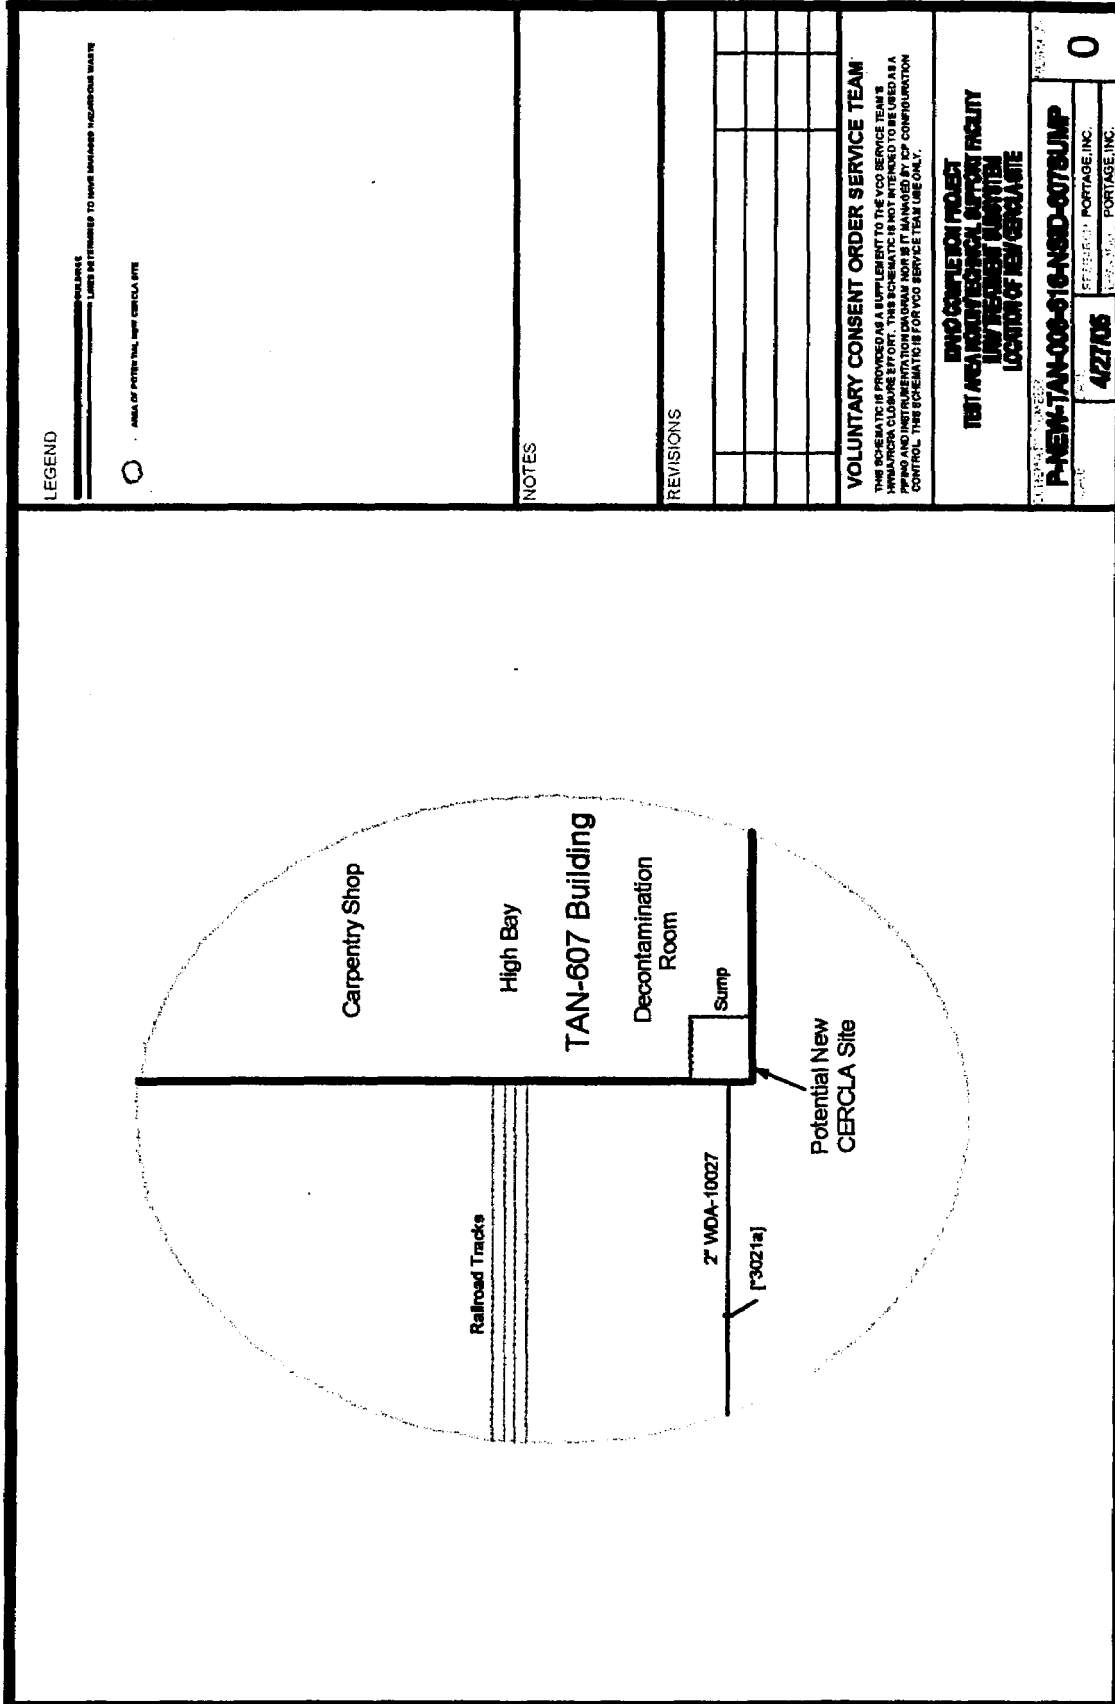
Attachment A

5. Description of Suspected New Site and Location: <p>The suspected new site is located beneath the former TAN-607 Decontamination Shop Sump in the southwest corner of the TAN-607 building. The TAN-607 Decontamination Shop Sump (01TAN00001) is a 600-gal sump that received low-level radioactive waste discharges from the decontamination room. The sump measures 1.2 m (4 ft) by 1.2 m (4 ft) by 1.6 m (5.0 ft) in depth. The sump was lined with epoxy-coated stainless steel in the late 1980's. The decontamination room was active from 1957 to approximately 1975. From 1975 until the mid-1980s, the decontamination room was maintained in standby status and operated periodically. From the mid-1980s to February 1990, the facility was maintained in reserve status but was not used. From February 1990 to the time the liner was removed in 2004 the facility was in cold standby. The steel-lined concrete sump was removed as part of HWMA/RCRA closure activities for the Intermediate Level Radioactive Waste Management System: Treatment Subsystem (TAN-616). In February of 2005 the original concrete floor and non-load bearing walls of the sump (north and east) were removed as part of the closure activities. Additionally, the TAN-607 load bearing walls of the sump (west and south) were scabbled to remove staining and remains of radiological contamination as outlined in the HWMA/RCRA closure plan.</p> <p>During removal of the grout between the sump liner and the original sump concrete floor, laborers noticed droplets of elemental mercury. Work was halted as the mercury was cleaned up, then as work continued additional droplets would form. This iteration continued several times until there was no more visible mercury. To remove the concrete floor the sump was cut into pieces that could be lifted out and put into a RCRA-compliant box. As several of the cuts were made, monitored levels of airborne mercury exceeded the OSHA Threshold Limit Value (TLV) (up to 100 ug/m³), indicating the presence of mercury. As the floor was lifted a small amount of elemental mercury was visible along the south and west walls of the sump. This mercury was removed prior to soil sampling activities. Radiological surveys taken just above the soil showed a general field of 5 mr/hr.</p> <p>Because observed conditions indicated a release of hazardous and/or radioactive material to the underlying soils, soil samples were collected and analyzed in accordance with provisions of the approved HWMA/RCRA closure plan. The analytical data indicate elevated levels of mercury (highest observed total concentration of 226 mg/kg), the presence of TCE and PCE, and elevated radionuclide concentrations (Cs-137 concentrations ranging from 55 to 12,100 pCi/g). Aroclor-1260 is also present in the soils. A comparison of the 95% upper confidence limit (UCL) to the preliminary remediation goals (PRGs) (OSWER No. 9355.01-83A) revealed that the concentrations of Co-60, Cs-137, U-235, and Sr-90 were greater than the PRGs for the occupational scenario. The risk for nonradionuclide constituents is approximately 2E-06, of which the Aroclor-1260 provides most of the risk. Without the Aroclor-1260, the risk from the remaining RCRA constituents is considerably less than 1E-06. A soil sample collected from the area with the highest mercury concentration was re-analyzed for TCLP metals. Results show that the soil is not characteristically hazardous.</p> <p>Prior to backfilling the excavation, a cover was placed over the soils for future identification. A locator ribbon was also placed approximately 1 ft above the cover such that the contaminated soils can be easily identified if future excavation activities are determined necessary. The depth of the contamination is unknown since only surficial soil samples were taken. A drawing displaying the location of this area within building TAN-607 is shown in Attachment A.</p>
