## NEW SITE IDENTIFICATION (NSI)

Site Title:  
Soil in Pipe Trench West of TAN-666

Site Code:  
TSF-55

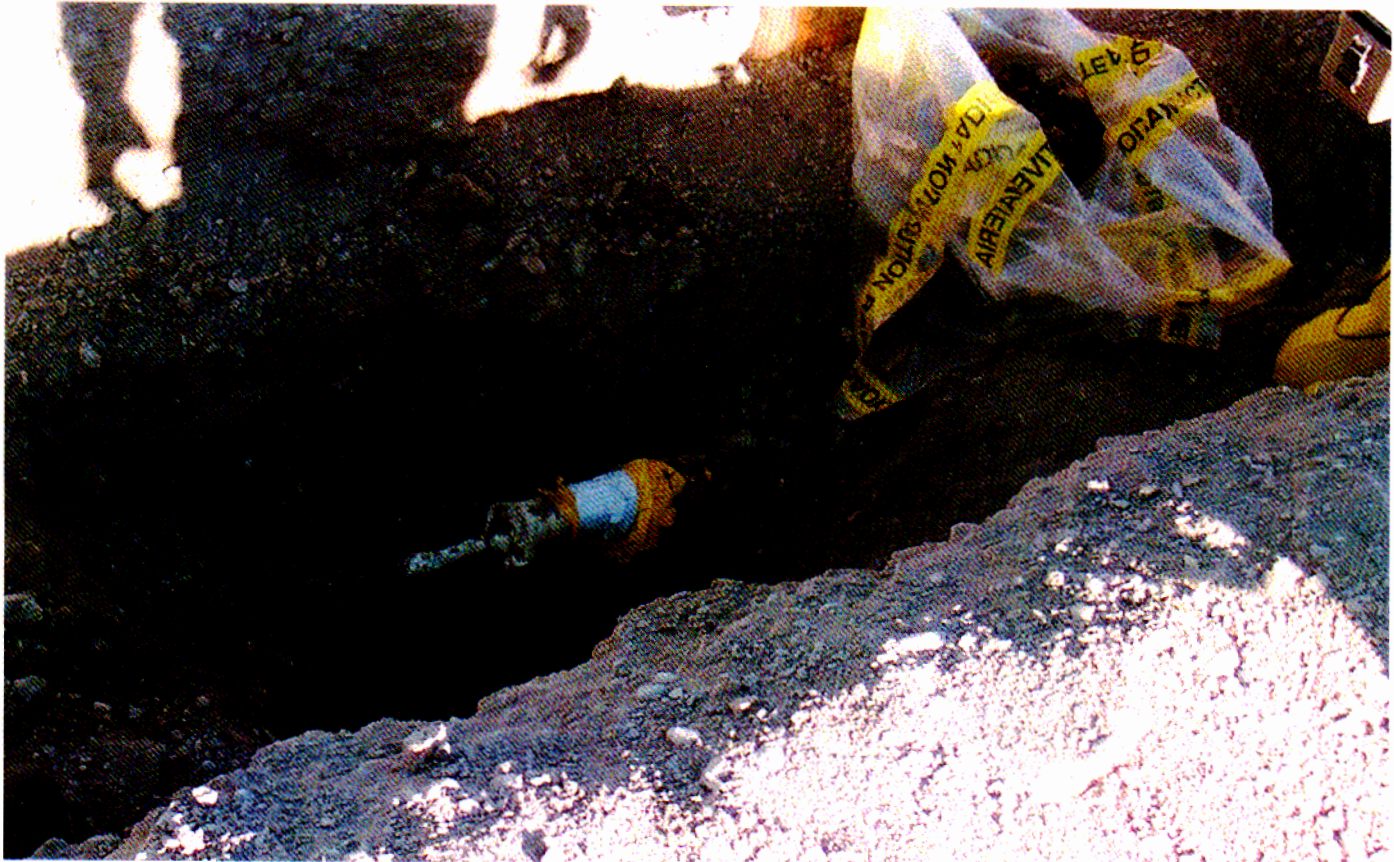
Figure 1: Picture of the south end of the carbon steel pipe where the proposed new site is located.
